Flood Hazard News

An annual publication of the Urban Drainage and Flood Control District

Vol. 44, No. 1

Rainfall – Runoff Analysis for the September 2013 Floods in Boulder, CO

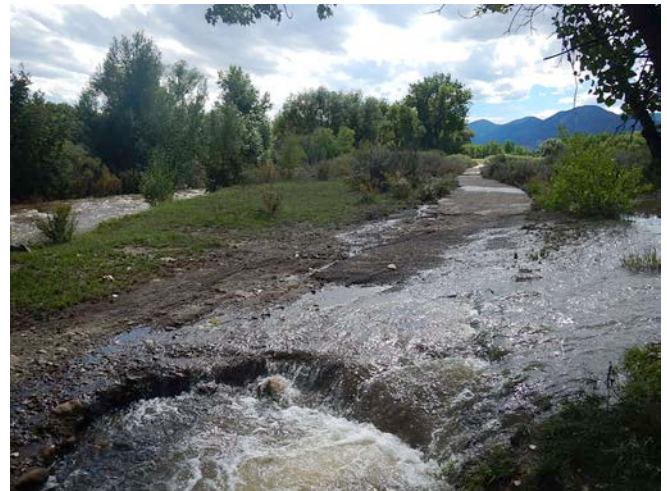
South Boulder Creek bike path washed out near U.S. Highway 36. Source: CH2M HILL

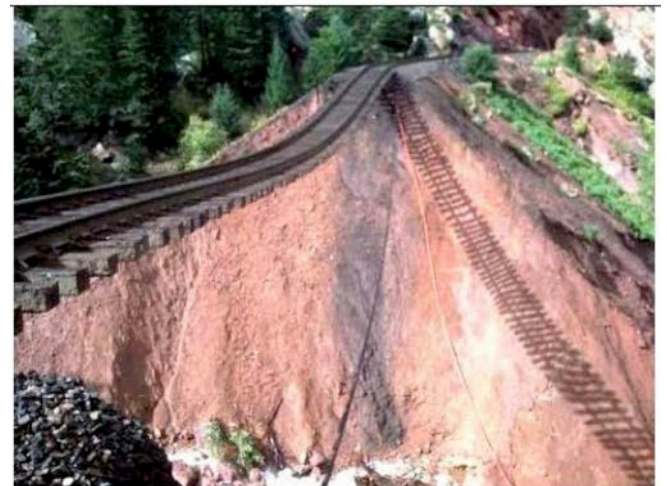
Bull Gulch post-flood railed railroad embankment (looking north). Source: Michael Baker International

It should be noted that the flow at this location was heavily influenced by a large (2,000 cfs) contribution from a tributary called Doudy Draw, which experienced very intense rainfall, well in excess of design storm parameters, in addition to a large surge of water and debris from a railroad embankment failure in a tributary called Bull Gulch. The area above the embankment failure was approximately 0.80 square miles (only a small portion of the overall watershed); however, the sudden release from the embankment failure, combined with the very intense rainfall drove the high runoff rates observed for the Doudy Draw watershed.

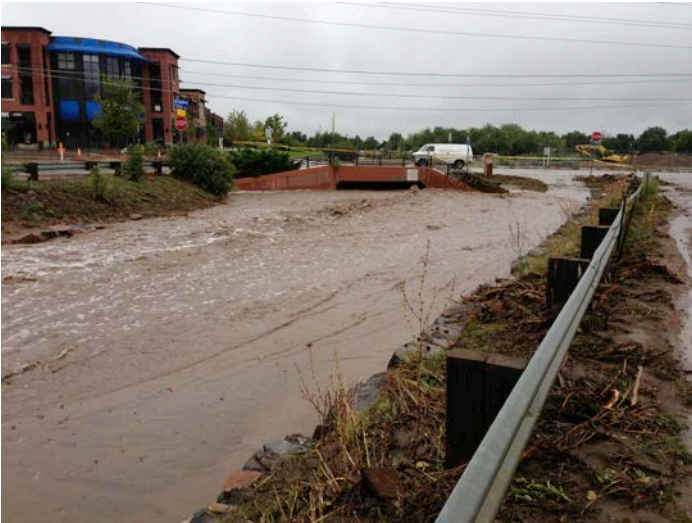
Fourmile Canyon Creek west of Broadway. Source: Muller Engineering Company

Fourmile Canyon Creek is a classic alluvial fan situation in an urban area. In large floods, there will be significant debris that will clog culverts, damage or destroy bridges, reroute flows, etc., and thus spread out from the apex of the fan at the base of the foothills. In the 2013 flood, there was significant channel avulsion (formation of a new channel)/migration upstream of Broadway on Fourmile Canyon Creek.

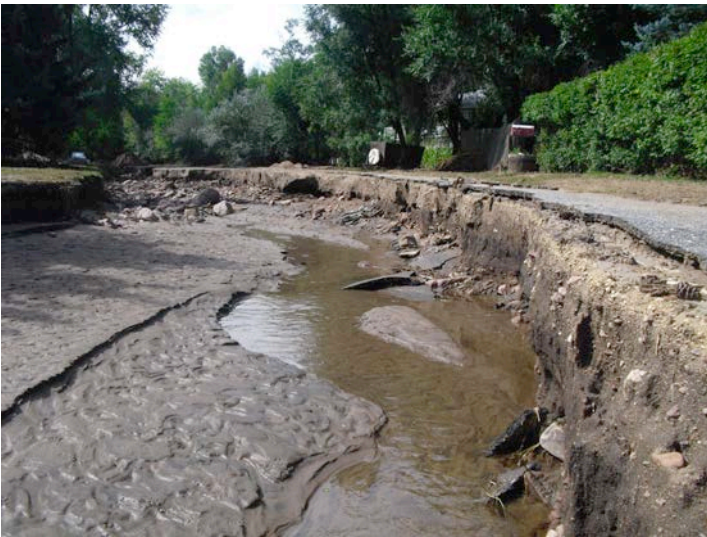
Fourmile Canyon Creek overflow path along Topaz Drive. Source: UDFCD

where flows from Fourmile Canyon Creek spilled to the south to Wonderland Creek.
