Maintenance Program Activities

Mark R. Hunter, P.E., Chief, Maintenance Program

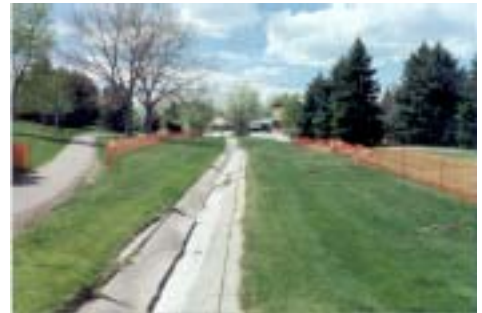
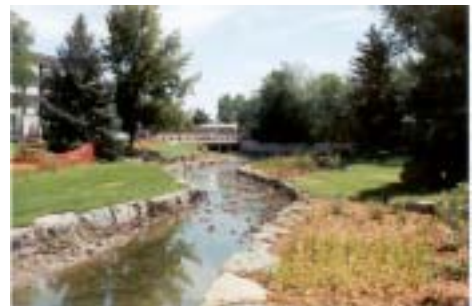
DeBoer Park low flow channel before and after.

The City of Denver also had a channel with a troublesome underdrain pipe. **Harvard Gulch** flows through DeBoer Park in south Denver. The underdrain was connected to multiple surface inlets with the intent of keeping the area dry during low flow periods. The thin slope-paved concrete of the trickle channel through the park had become displaced and broken-up to the extent that the trickle flows went under or around the inlets and never made it to the underdrain pipe. With the coordination of Denver Parks the five-foot wide concrete trickle channel was replaced with a boulder-edged low flow channel that varies from 10 to 15 feet wide.
