# Rebuilding Henderson Gage Control Section

by  
Ben Urbonas, P.E. and Bryan Kohlenberg, P.E.

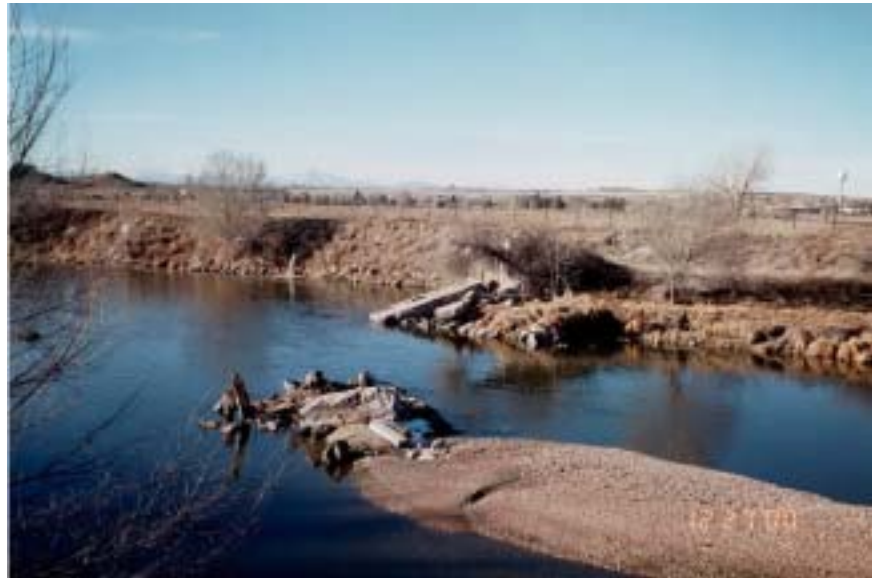
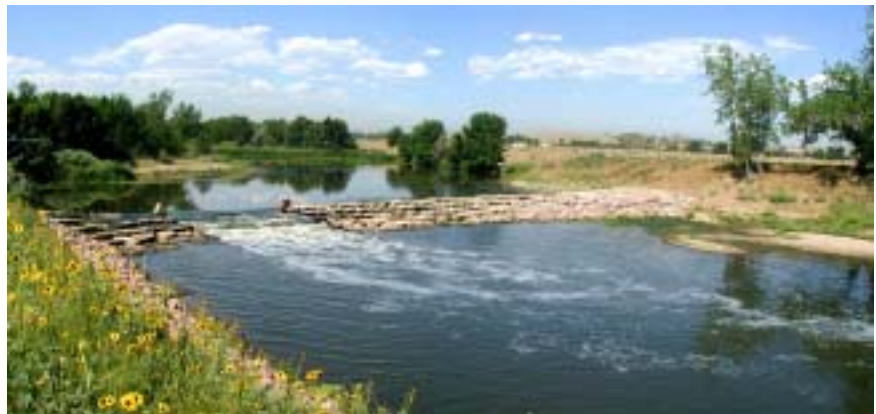
**Before and after views of the gage control section**

Notice the cleanup of the site that occurred as a result of this project (see the before and after photographs on this page). Over the years much rubble was dumped on the River's channel bottom and its banks at this location. All of this rubble and other trash were removed, the site regraded and then revegetated

with native vegetation and grasses. Unfortunately the very dry weather that we experienced in 2002 retarded the reestablishment of the new vegetation, but we expect it to green up when the conditions return to normal.

Three options to correct this problem were possible. One was to abandon the gaging site. This was really not an option, since too many water users and data collectors depended on this gage for information. The second option was to totally rebuild the gaging site, including the wet well and all of the flow measuring and water sampling equipment. Although this option was viable, the Division had no funds for such an undertaking and it would have disrupted many of the data and water sampling efforts for an extended period of time. The third option was to install a grade control structure immediately downstream of the gaging site to restore the thalweg so as to permit recording of low-flows again at this gaging site.

1. Grade and flow stage control
2. Reaeration of the River
3. Reasonably safe boater passage
4. Unimpeded fish migration
