# Maintenance Program Activities

**Mark R. Hunter, P.E., Chief, Maintenance Program**

## Routine Maintenance

## Restoration Maintenance

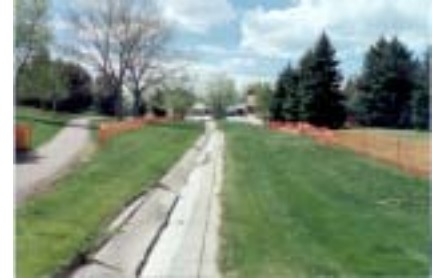
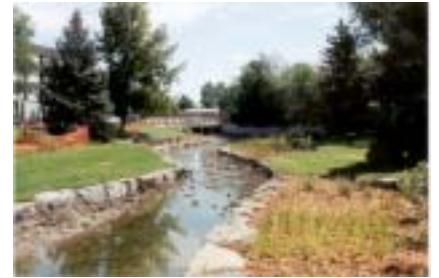
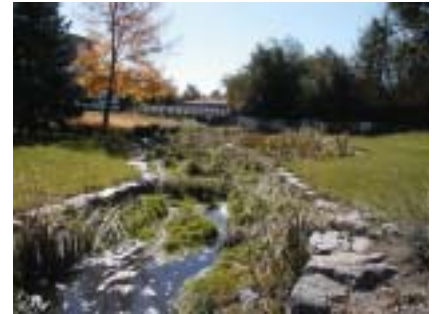
**Harvard Gulch Low Flow Channel**

**Before construction**

**Immediately after construction**

**One year later**

Creeks in our semi-arid region tend to have a mind of their own when it comes to the width to depth ratio for the low flow channel. **Harvard Gulch** flows through DeBoer Park in south Denver. It had a thin slope-paved concrete trickle channel that had become displaced and broken-up. Last year the five-foot wide concrete trickle channel was replaced with a boulder-edged low flow channel that varies from 12 to 18 feet wide. The outcome is an attractive creek corridor through an irrigated park. An additional feature that has developed over the past year is that the creek has deposited sediment in the now-wider low flow channel. The result is mounds of material and volunteer vegetation scattered throughout the creek alignment that have become a maintenance issue for us and the parks department.

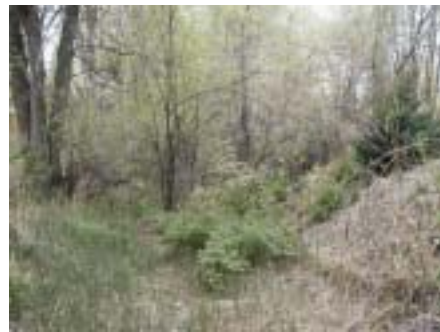
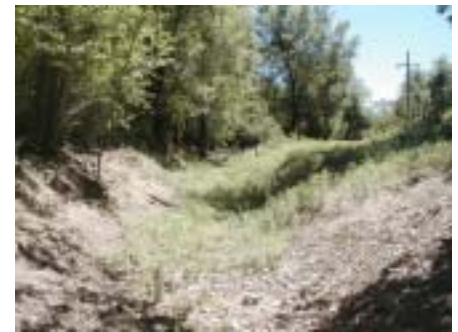
Regular routine mowing of portions of the Minnesota Drive Tributary prevents overgrowth of vegetation around the storm sewer outlets draining to Cherry Creek. Despite the mowing at the outlets the rest of the stormwater channel had become a tangled mess of invasive weeds, shrubs, suckers and dead branches.

**Before and after views of Minnesota Drive Tributary.**

This gnarled jungle was thinned out in July, 2002, to restore capacity and facilitate maintenance of Minnesota Drive Tributary. This tributary runs parallel to Cherry Creek along residential backyards between Monaco and Holly Street in Denver, Colorado.

A private contractor was paid \$4,490.00 to cut and remove all woody vegetation within the channel as well as remove the lower branches of mature trees up to a height of approximately six feet above the ground. The result is a drainageway free of organic debris that more

effectively prevents flooding near the homes that line its southern bank while also facilitating access by maintenance crews.
