Maintenance Program Activities

Mark R. Hunter, P.E., Chief, Maintenance Program

Restoration Maintenance

Rehabilitation Maintenance

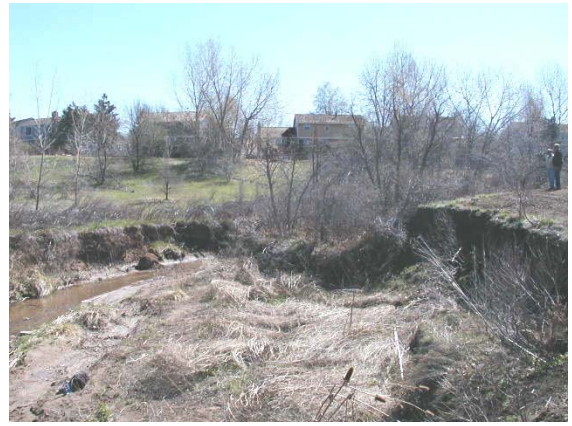
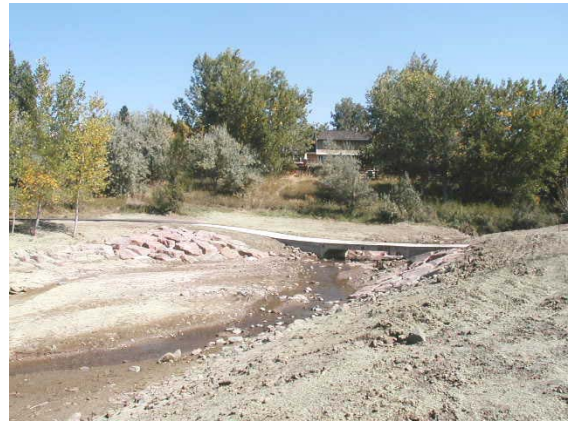
Willow Creek at County Line Rd. before and after.

Recent upstream urbanization in the **Willow Creek** basin in Douglas County resulted in renewed down-cutting and bank erosion just north of County Line Road in Arapahoe County. Four isolated grouted boulder drop structures were built with very little work done between the structures. This allowed most of the existing native grasses and thick trees to remain in what will now be a more stable setting. Since the Willow Creek watershed is in the plains we did not have to alter the construction schedule because of snow-melt runoff from the foothills. What we could not predict was the frequent runoff events as thunderstorms frequently rumbled across the southern part of the Denver area. Our contractor endured multiple weather delays during the construction.
