Maintenance Program Activities

By Mark R. Hunter, P.E., Manager, Maintenance Program

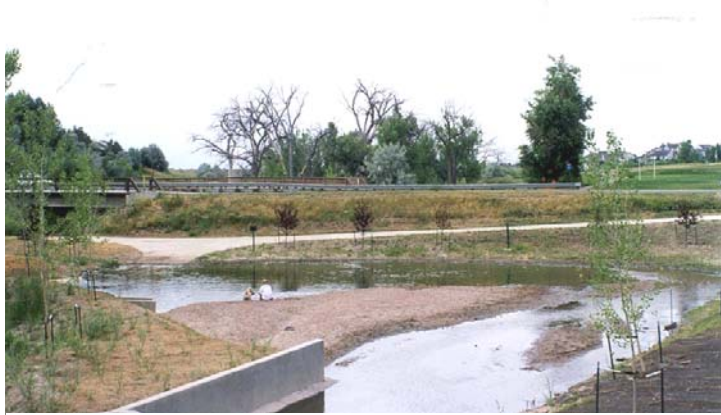
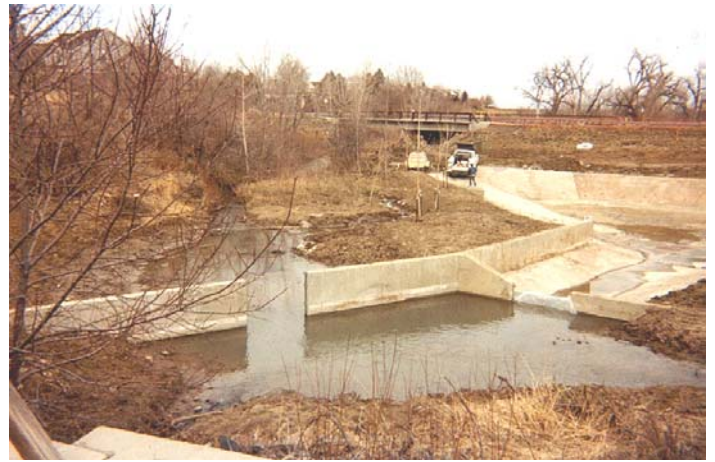
Left: Willow Creek sediment trap at Dry Creek Road. The pond is full with 800 to 1000 cubic yards of sediment. One of our indicators for when it is time to remove the sediment is when people start having picnics on our "beach." Right: The left side of photo shows the Willow Creek channel. The freshly cleaned sediment trap is on the right. The diversion boards are still in place to keep water out of the sediment trap while it is being cleaned.

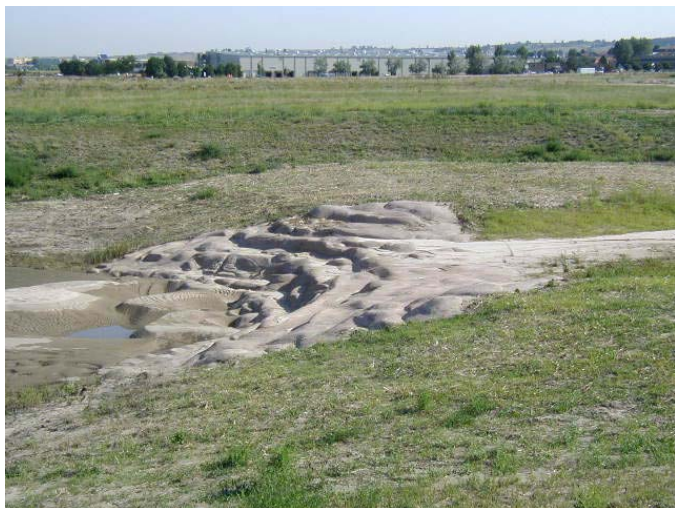
A detention pond was built in the late 1990s on the **Long's Way Tributary** near it's confluence with Cherry Creek in Parker. At the downstream end of this pond a lowered micro-pool had been installed to trap sediments and provide a maintainable feature that

would improve the quality of the water discharged from the pond. The five foot elevation drop from the trickle channel into the micro-pool was made of graded earth. When the pond would detain water the elevation difference was drowned out by the water and little or

no erosion occurred. However, at lower flow rates erosion was occurring as the water dropped into the micro-pool. Our solution was to restore the micro-pool by creating a sculpted concrete drop structure with a concrete cutoff wall to separate the main detention pond from the micro-pool.

Long's Way Tributary sculpted concrete drop structure.

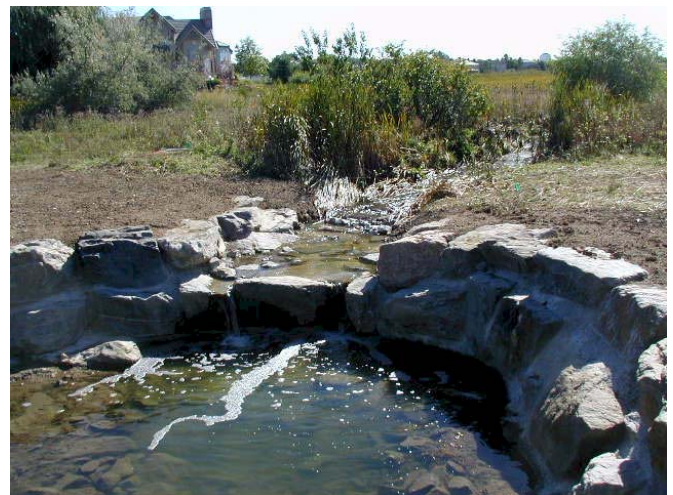
Drop structures can fail when water flows through, under, or around them due to an inadequate cutoff wall. We repaired several drops in 2004 that suffered from poor cutoff walls. Grouted boulder drops were built on **Greenwood Gulch** north of Orchard Road in Greenwood Village in 1999. The excavated trench for the original grout curtain simply did not extend to the depth called for in the plans. We repaired 4 of these drops a couple years ago and repaired an additional one in

Greenwood Gulch drop structure. The sheet pile cutoff wall is hidden behind the grouted boulder drop structure.

2004. We were able to clean up the upstream side of the boulders and then drive sheet pile and grout it in place to bind the whole structure together.
