Information Services and Flood Warning Program Notes

SPECIAL REPORT: The Rains & Floods of September 2013

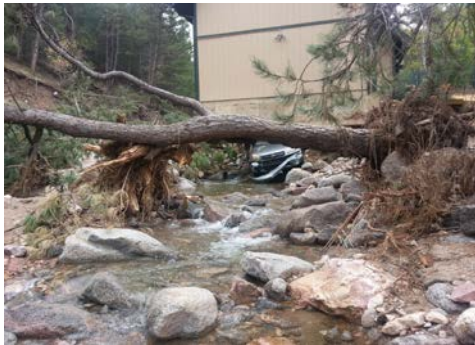
September 2013 flood damage along Fourmile Canyon Creek in Boulder County near UDFCD border

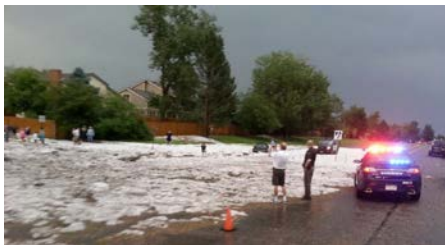
Jefferson County (photo) and portions of northern Douglas County received 2 to 3 inches of rain accompanied by copious amounts

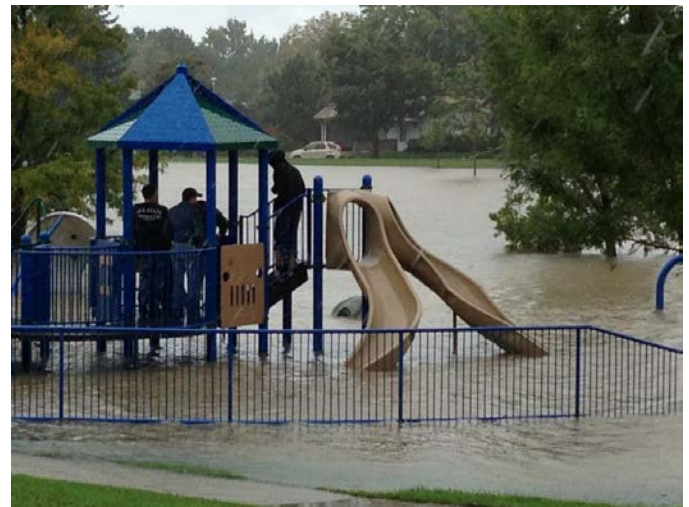
Utah Park in Aurora, Colorado is a detention basin that worked as designed to minimize damage from floodwater to neighboring property during the September, 2013 flooding.

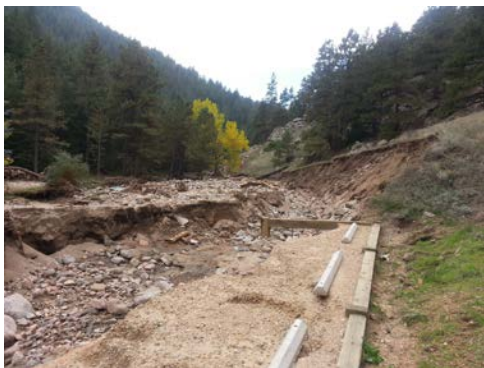
New channel cut by Fourmile Canyon Creek in Boulder County near UDFCD border. Actual creek channel is left of photo. Damaged parking area served the Anne U. White Trailhead prior to the flood.

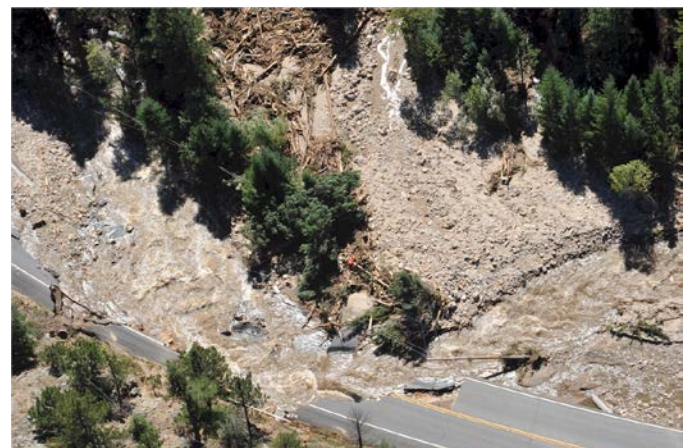
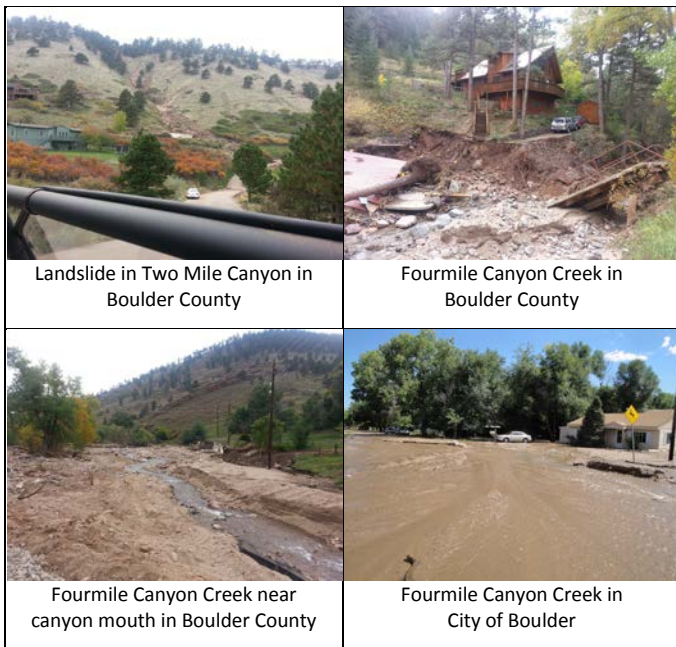
steep mountain slopes gave way, thousands of tons of sediment, large rocks and fallen trees reached valley floors and flooded streams. Stream banks, roadways and buildings collapsed adding to the debris being carried by floodwaters. At points where the movement of debris was either obstructed or slowed, temporary dams formed and the water backed-up until the failure point was reached. Then a large surge of water would impact a relatively short distance downstream where walls of water were reported by witnesses. Eventually the debris load would be deposited. This condition was commonly observed throughout the high country and adjacent plains during the flood.

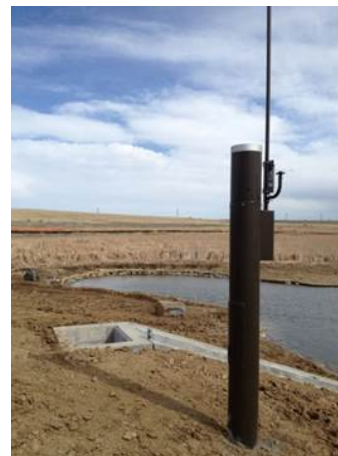
East Toll Gate at Hampden Rain/Stage Gage

The ALERT system currently collects real-time data from a network of six repeaters that receive transmissions from 219 gaging stations accommodating 195 rain gages, 103 stream gages and 26 full weather stations. Two new stations were installed by the City of Aurora in 2013—a combination rain/stage gage on East Toll Gate Creek at Hampton Avenue and a rain gage at the Blackstone Golf Course. Both sites employ a new more robust data protocol known as ALERT2™.

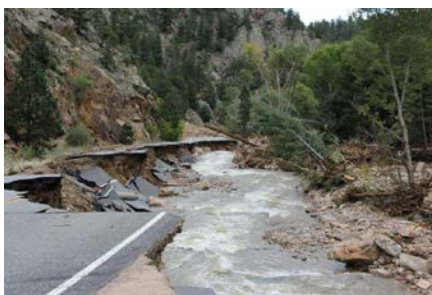
Some other failures also occurred in 2013 that are not easy to guard against. The September floods damaged or destroyed 15 ALERT streamgages, 10 of which were located

in Boulder County. The photo shows what happened at the James Creek streamgage near Jamestown. Streams affected include Boulder Creek, Fourmile Creek, South Boulder Creek, North Saint Vrain, South Saint Vrain, Left Hand Creek and
