Flood Hazard News

An annual publication of the Urban Drainage and Flood Control District

Vol. 41, No. 1

December, 2011

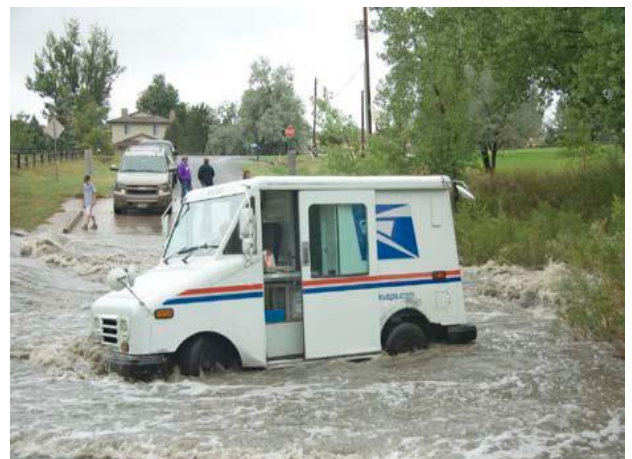
Piney Creek and Caley Drive - Before

Piney Creek is a sand bed channel that is confined by residential development along the majority of its banks. The continuous development and loss of pervious area in the watershed keeps changing the nature of the stream. Piney Creek went from an ephemeral to a perennial stream. The result of these changes has caused an imbalance in sediment load, incising of the channel, and severe bank erosion. The residents were experiencing property loss, and adjacent structures were being threatened. An even more apparent problem in this area was the street crossing of Piney Creek to get into the residential area. This street-channel crossing was at-grade and became dangerous to cross even in more frequent rainfall and runoff events. When the creek rose from storms or iced over during the winter months it caused unsafe travel conditions.

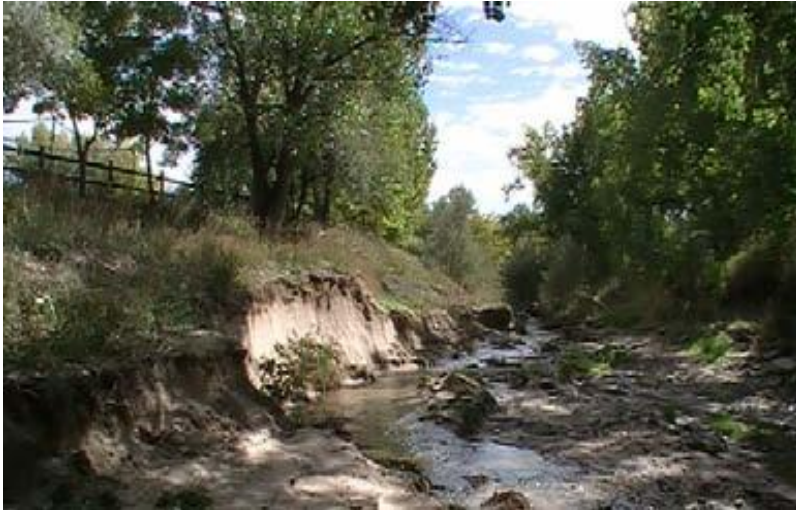
Piney Creek - Before

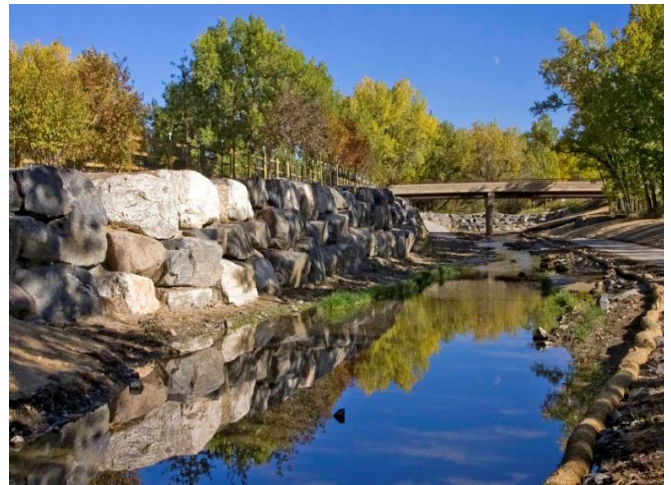
Piney Creek - After

- Caley Drive Bridge consists of a concrete box girder 125-feet long and 27-feet wide that accommodates a 100-year flow of 8,600 cubic feet per second.
- Stream Stabilization includes an 8.5-foot tall grouted boulder drop structure, sheet pile check structure, 200 linear feet of grouted boulder bank protection, and 500 linear feet of low flow channel.
- 1800 linear feet of 36 inch to 54 inch storm sewer.

The Piney Creek Stream Stabilization, Bridge Crossing and Storm Sewer Outfall project successfully met the project goals to stabilize channel, improve the water quality, improve the Caley Drive crossing, and provide a storm sewer system to the south. The project provides safer access for the residents and reduces the risk of damage to private property and threats to adjacent structures.

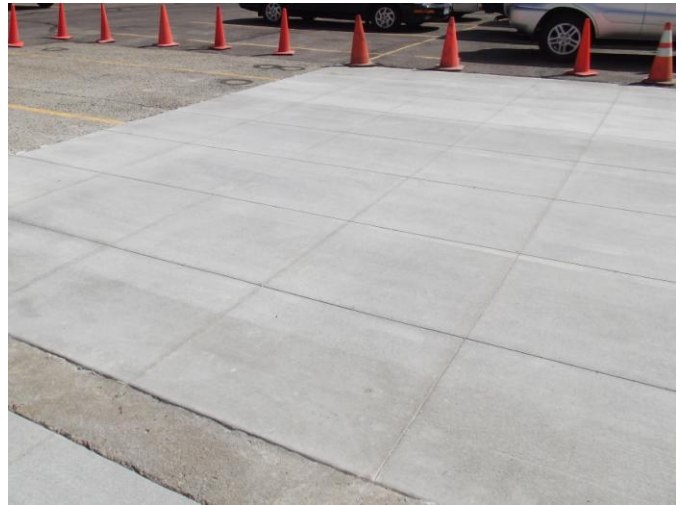
New permeable pavement test pad in Lakewood

We expanded our permeable pavement research with construction of a new type of permeable pavement at our BMP test site in Lakewood, CO. The site previously contained pervious concrete constructed using different aggregates. When one section of the pervious concrete started to ravel, UDFCD looked for another opportunity. The concept of the new pavement was developed by Colorado Hardscapes under the name *Hydrascapes*. Although the name is trademarked, the construction technique, which includes saw cutting of conventional concrete, remains available to the construction community. The wearing course consists of conventional concrete with a pattern of full depth cuts (perpendicular to

flow) that extend into the aggregate below. Use of conventional concrete allows flexibility in appearance, color and pattern as well as potential for wide spread use. A skilled installer will make the full depth cuts indistinguishable from the control cuts giving the pavement the appearance of pavers. This also expands potential use of the pavement to more decorative areas at a lower cost compared to permeable interlocking concrete pavers (PICP). Colorado Hardscapes constructed this approximate 1000 square foot pad in August of 2011. UDFCD plans to conduct yearly infiltration tests and determine maintenance recommendations and promulgate design criteria dependent on performance over the next several years.

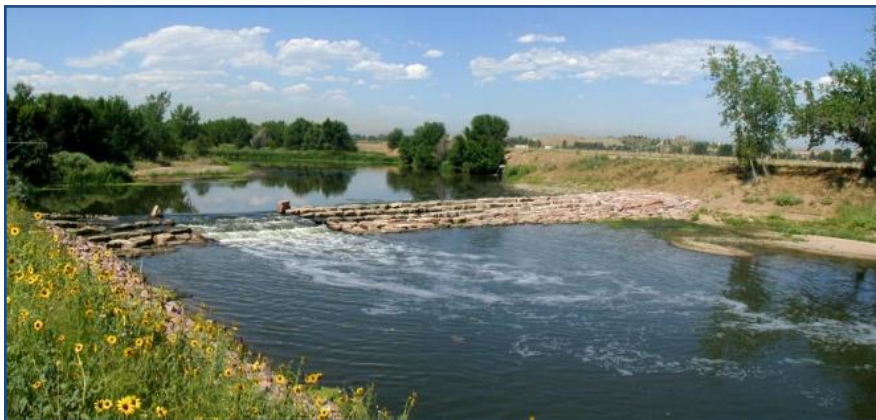
This re-aeration structure is a product of UDFCD's capital improvement program, matching local funds to construct infrastructure that manages river flows safely and improves water quality in the process.

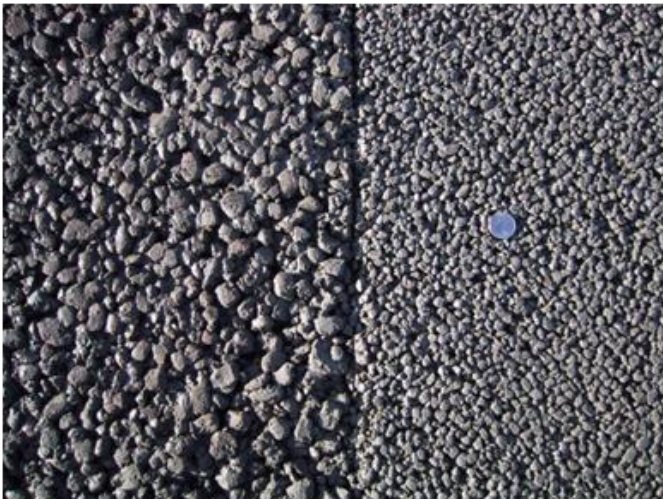
Photograph 1. The installation included two mixes utilizing different aggregates, AASHTO #67 (left) and AASHTO #8 (right).

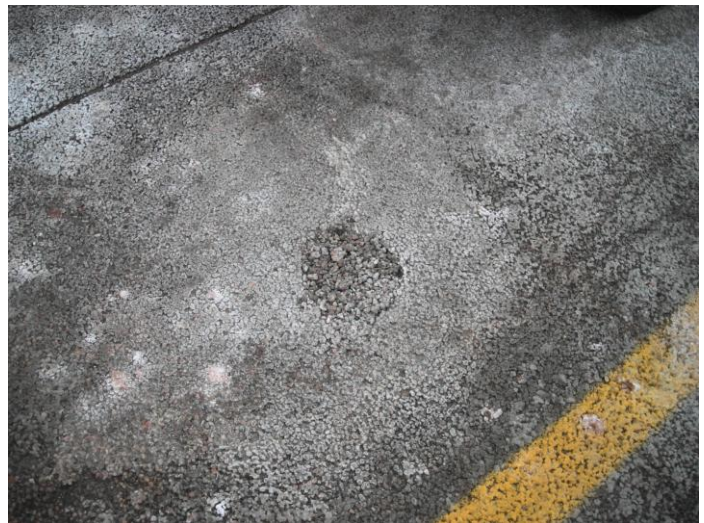
Photograph 2. In December 2009, the section with small aggregate started to ravel. It spread quickly, by January 2010 a number of areas showed raveling in excess of 2 feet in diameter.

The Lakewood installation is considered successful compared to other installations constructed previous to the new specification. Neither the large or small aggregate sections showed any surface damage going into year four of the study. In December 2009, the small aggregate section started to ravel. Left alone, the raveling spread relatively quickly, by January 2010 a number of areas showed raveling in excess of two feet in diameter. As of December 2011, the large aggregate section remains undamaged.

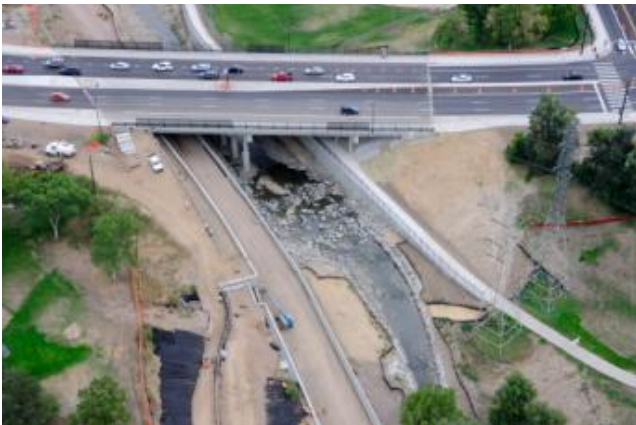
Lakewood Gulch drop at Federal Boulevard. Photo date is September 12, 2011. This was the largest of the six drop structures built as a part of the RTD West Corridor FasTracks Project. View is looking east and downstream.

We have worked with RTD, the City and County of Denver, the City of Lakewood and Jefferson County on this project since the summer of 2004. Denver Transit Construction Group JV (DTCG) commenced construction in the spring of 2009. We are now winding down the third construction season and the end is in sight! Major construction activities this year have been focused on the Lakewood Gulch drop

structure at Federal Boulevard and the downstream reach that interfaces with the Denver and District's South Platte River and Lakewood Gulch Project in Denver, and the Dry Gulch channel improvements at Harlan Street in Lakewood. Joanna continues to do an outstanding job of keeping this large, long and complicated project on track (pun intended) for District Maintenance Eligibility. I also want to acknowledge the contributions that Bruce Behrer and Chris Kroeger of Muller Engineering Company made relative to the Federal drop structure construction. The success of that element was a joint effort on the part of all parties involved. All major drainageway construction phases should be complete in February of 2012.

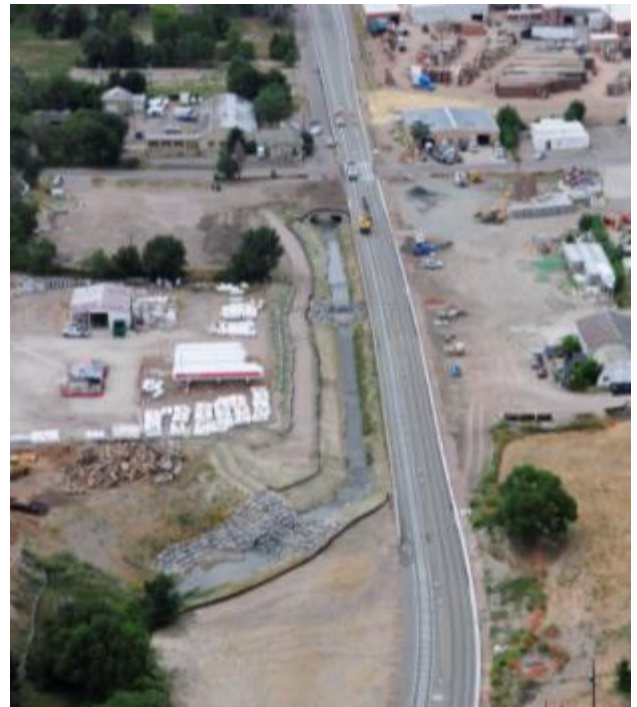
Dry Gulch channel improvements in Lakewood. View is looking west towards Harlan Street. The Light Rail line is bounded by a park and industrial development and adjacent to the channel. The upstream headwall is the confluence of Dry Gulch and North Dry Gulch. This photo was taken on September 12, 2011.

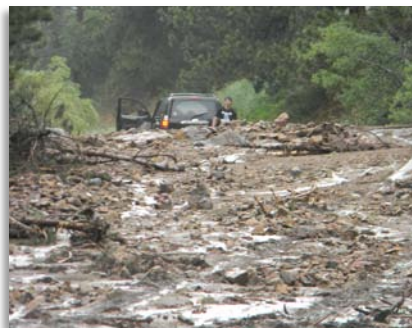
100-yard wide by 4-foot deep debris/rock/mud slide, forcing the closure of Fourmile Canyon Drive near Emerson Gulch where the 2010 fire started. The burn area rain was on the northern edge of a much larger storm cell that prompted the NWS to issue a flash flood warning for the FMBA at 6:19 pm as it approached (see above map). Fortunately the intense portion of the storm missed its target. Had the storm cell in Boulder County centered over the FMBA, the impacts in the burn area and downstream through Boulder would have been devastating. July 7 held its status as the largest heavy rainfall day of the year in the District (see later discussion).

The NWS morning forecast models for Thursday, **July 7**, indicated a lower threat level than the prior two days. Therefore, a flash flood watch was not issued. By late afternoon a small amount of rain fell over the FMBA causing a

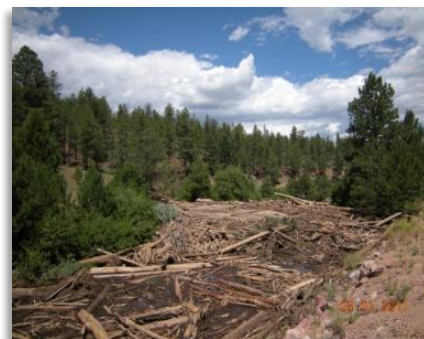
reported 1.2-inches of rain, consistent with Radar-estimated amounts. While flood damages were minimal, an impressive amount of debris once again accompanied the storm runoff as shown in the August 1 photo provided by the USGS. It is interesting to note that this type of impact is still occurring from such a small rainfall event so long after the 2002 fire that burned over 138,000 acres. Should those living in the Fourmile Burn Area in Boulder County expect the same?

The Hayman Burn Area in southwest Douglas County experienced another debris-loaded flash flood on this Friday afternoon, **July 29**. The NWS issued a small stream flood advisory for this area at 3:54 pm. Trained weather spotters

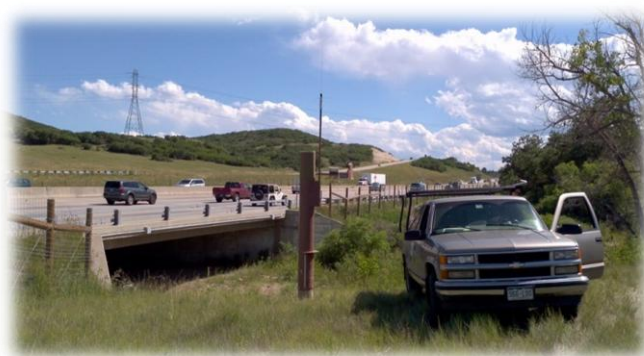
New gaging station on Happy Canyon Creek at I-25 in Douglas County.

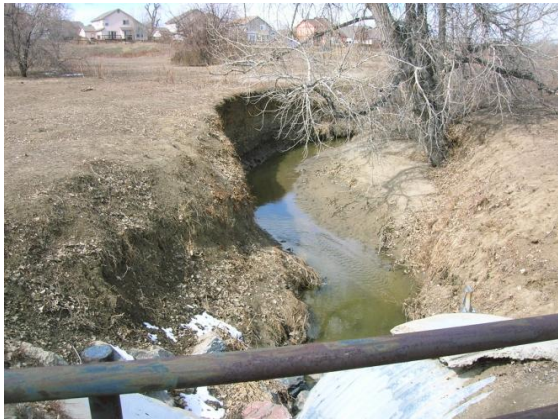
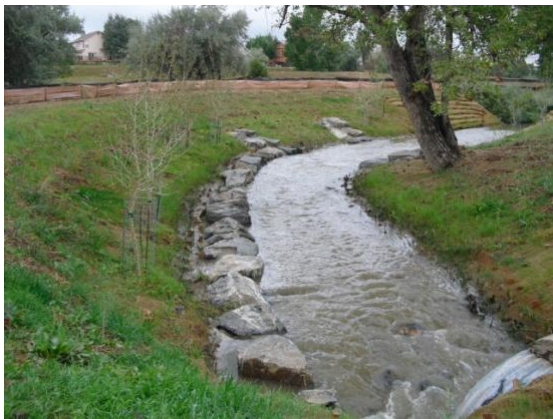
Grange Hall Creek before and after

The improvements included re-aligning the sanitary sewer to move it away from the creek, installation of grouted boulder drop structures, laying back eroded side slopes, and the installation of wrapped soil lifts. Wrapped soil lifts were used in areas of steeper side slopes up to 2-to-1. The wrapped soil lifts were planted with willow stakes harvested from an adjacent stand of willows, upland shrubs, and cottonwood poles.

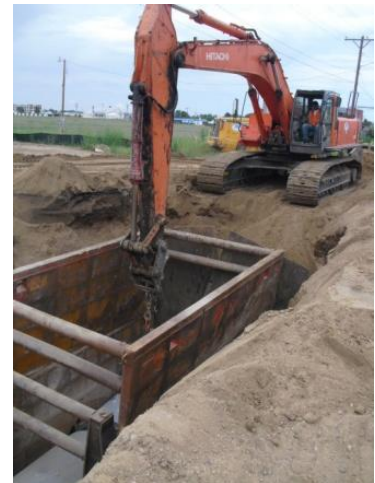
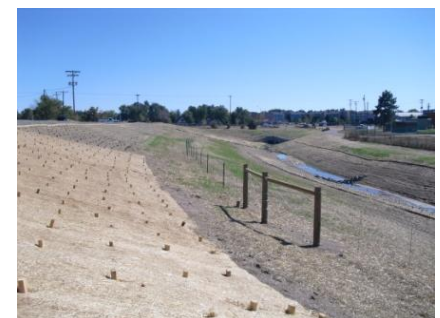
North Outfall pipeline construction and finished outfall channel

Storm Sewer improvement project. This project will provide much needed storm sewer improvements for the greater part of downtown Brighton.

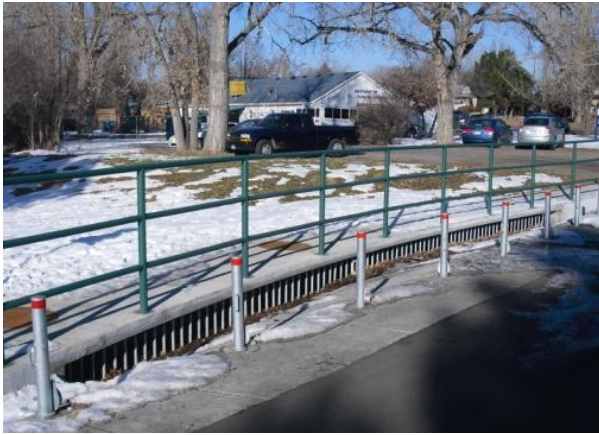
Shaw Heights Tributary completed 45-foot special curb inlet

This project installed a special 45-foot long open throat sump inlet that will capture the 10-year storm and convey it to a new storm sewer along Circle Drive. An overflow was constructed to convey runoff in excess of the 10-year storm from the inlet to the Allen Ditch. The new storm sewer along Circle Drive drains to an enlarged storm sewer system along Wagner Drive that replaced an older undersized system. The Wagner Drive storm sewer outfall flows into the detention pond at Rotary Park, which was built in 1990 as a previous District project. Improvements were made to the Allen Ditch to provide a controlled spill location so that single family residences along the ditch can be protected from storm runoff intercepted and conveyed by the ditch.

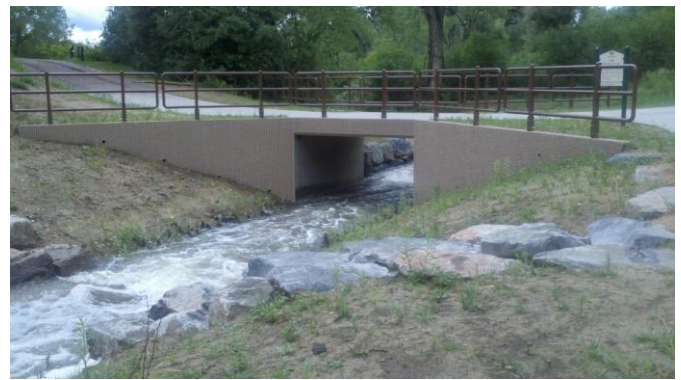
Lee Gulch at the High Line Canal after construction

protected with boulder edging and soil riprap. The old corrugated metal pipes were replaced with a concrete box culvert. The new crossing allows year round use of the trail and improved maintenance access. Willows and native grasses were planted in the disturbed areas. The project was put to the test right away with high flows from the storm season and the flushing of the Highline Canal. The project held up well with no damage observed.

The District, City of Littleton and South Suburban Parks and Recreation District completed a maintenance project on **Lee Gulch at the Highline Canal**, located southwest of Broadway and Dry Creek Road. The existing undersized culverts would over top in storm events effectively closing the trail. Constant erosion of the channel was another problem. The project provided grade control with the construction of a boulder drop structure. The banks were

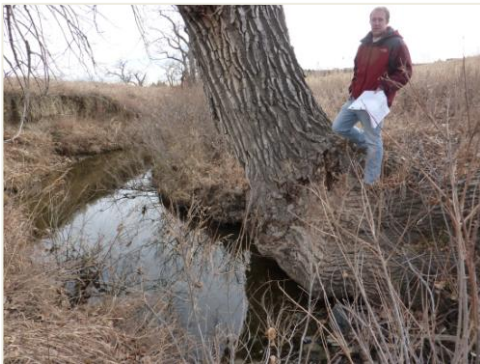
Rock Creek pre-construction conditions

In the winter of 2011 Boulder County and the District completed maintenance improvements along **Rock Creek at the Carolyn Holmberg Preserve**. Agricultural and ranching activities had impacted a section of Rock Creek, resulting in a severely incised channel with 5- to 8-foot tall eroded vertical banks. Based on field observation and review of historical

aerial photographs, it appeared that the alignment of the channel had moved significantly from its historic course, which contributed to the bank and bed erosion. If left alone, the channel would continue to erode and cut a deep channel upstream further degrading more reaches of Rock Creek. The purpose of the project was to repair the stream bank and bottom erosion and restore aquatic and riparian habitat to Rock Creek.

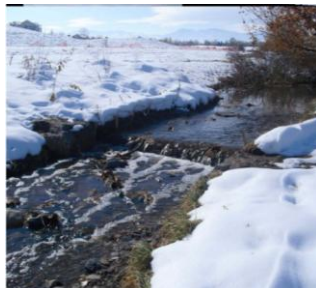
Completed timber drop

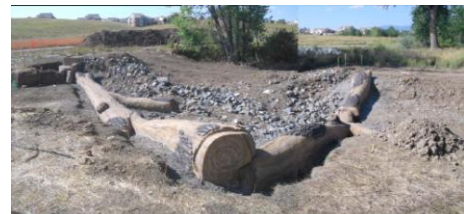
Concrete log drop during construction

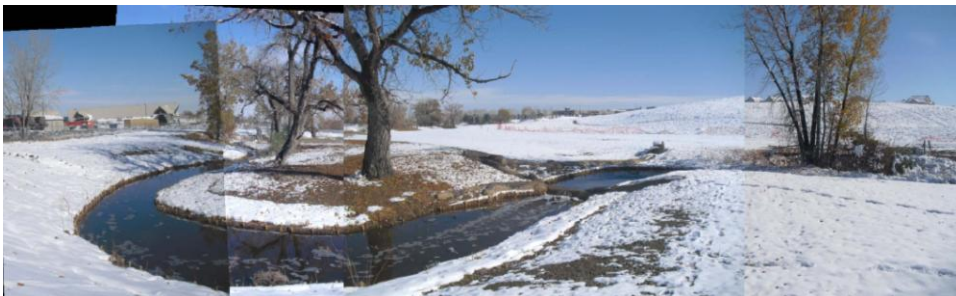
Post-construction view of concrete log drop and bio-logs

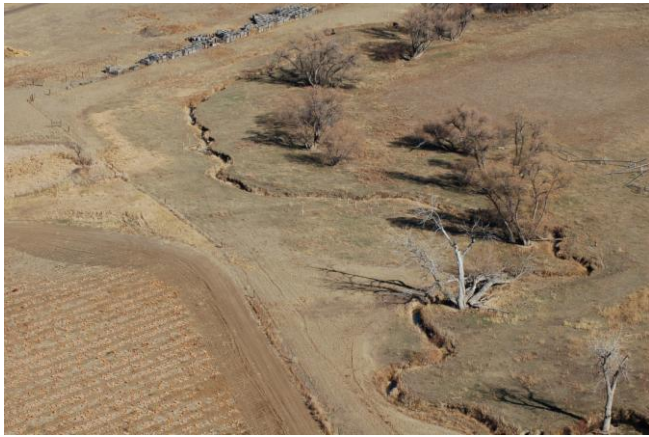
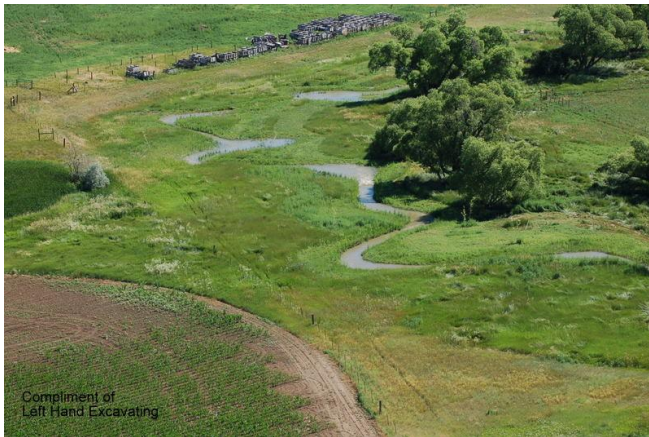
Before and after views of Rock Creek at the Carolyn Holmberg Preserve

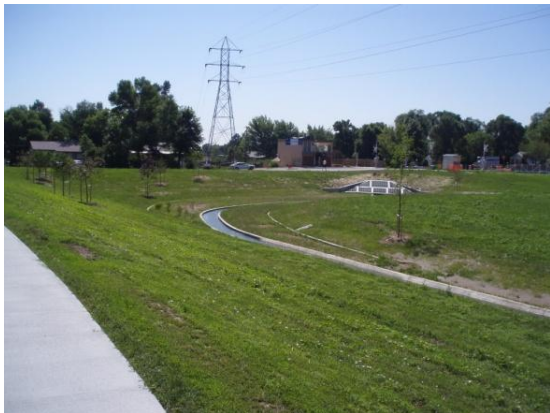
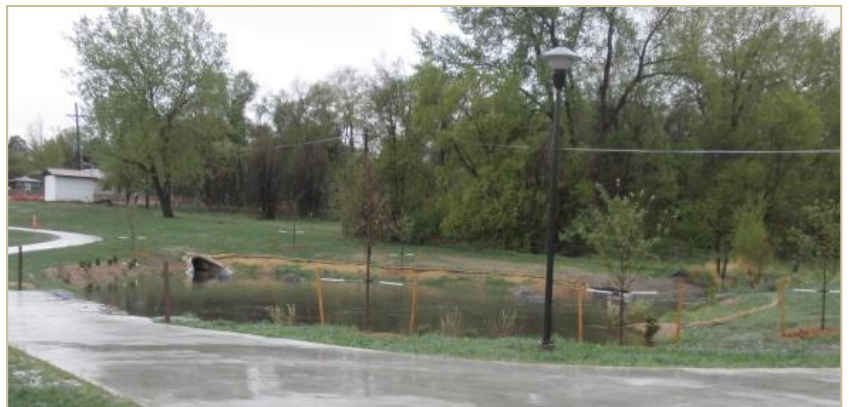
Richey Park detention after construction, looking downstream at the pond outlet and upstream at the forebay

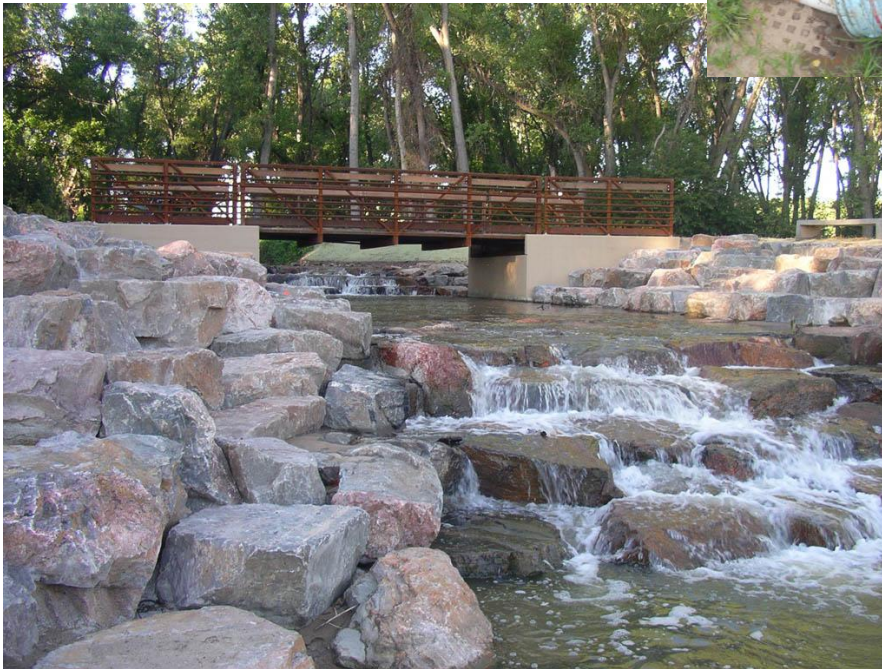
Finished drop structure looking upstream at Marcy Gulch. (Inset) Trout caught in Marcy Gulch

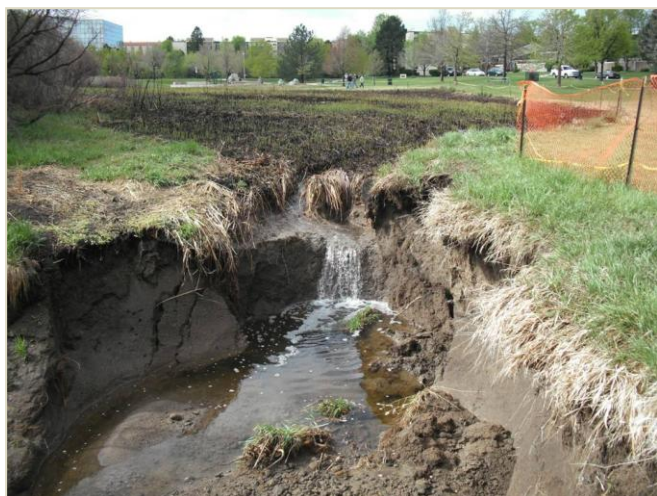
Looking south at the existing channel, erosion threatens community of wetlands and overall corridor.

Channel degradation, however, has compromised much of the Southmoor Tributary north of the project reach resulting in an incised channel which has negatively altered the riparian belt. The degradation is migrating upstream threatening the stability and ecology of the channel. Aggradation has compromised much of the low flow channel within the project reach resulting in unconfined storm flow conditions. This condition has encouraged bypass flows to Goldsmith Gulch during even the smallest storm. SEH was contracted to assist the District and the City with the design of an improvement plan that would arrest the existing instability while preserving the natural character of the corridor.

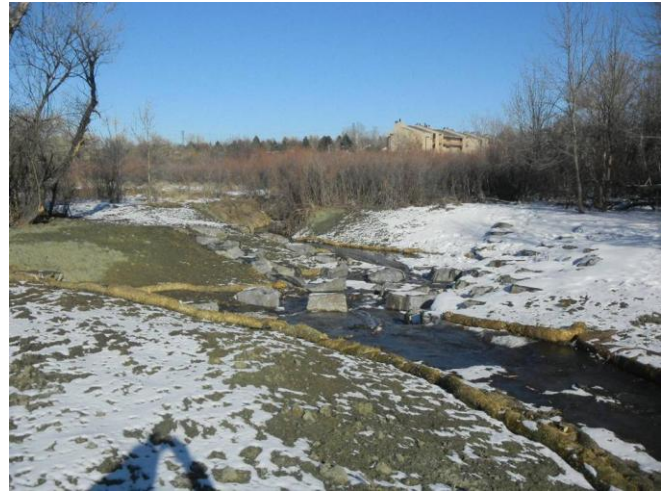
Looking north at improved corridor, partially grouted drop structure stabilizes the channel and protects upstream wetlands

The vision was to manage the degradation while restoring the Southmoor Tributary low flow channel. The challenge during design and construction was deriving a practical and constructible low flow edge since it was key to the sustainability of the low flow channel. Soil lifts were constructed to form a rigid boundary that would prevent the migration of cattails into the low flow channel. Planted with bull rushes and a variety of wetlands grasses, the low flow channel will not only reconnect the upper and lower reaches of the tributary but also diversify the wetland community. Naranjo Civil Constructors was instrumental in implementing the vision with completion achieved in the December 2011. Wetland plugs for the soil lifts and channel bottom is scheduled for the spring 2012. Thank you to the City Public Works and Parks for their collaboration on the project.

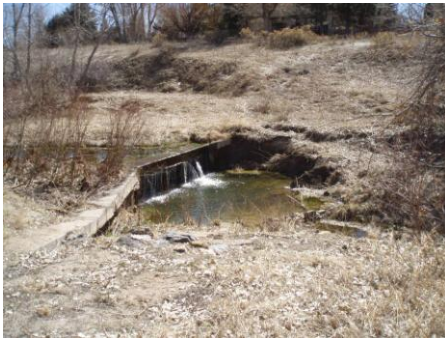
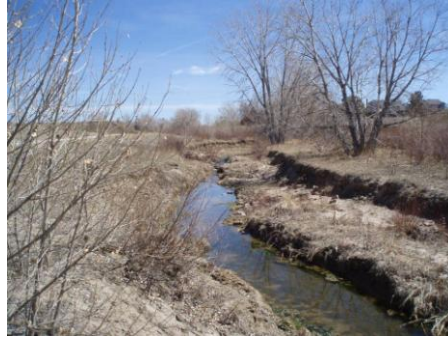
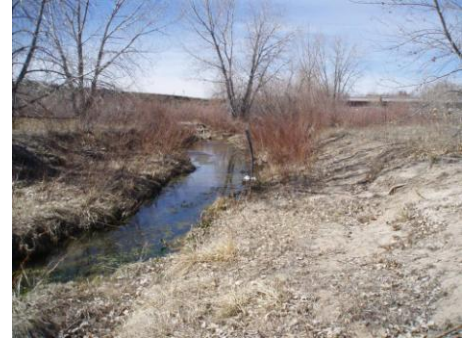
Check structures (left) had been installed to keep potential degradation to a manageable level (center and right)

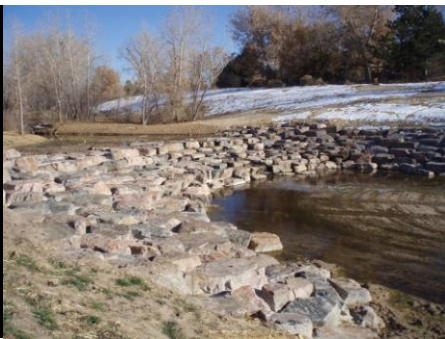
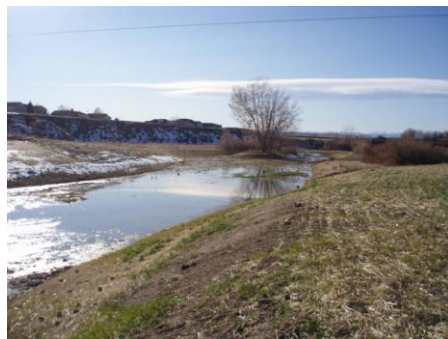
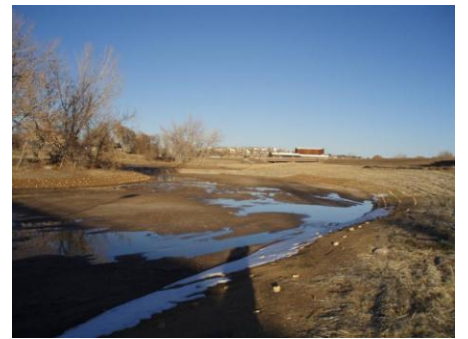
The check structures were turned into drop structures (left) and the channel was reshaped (center and right)

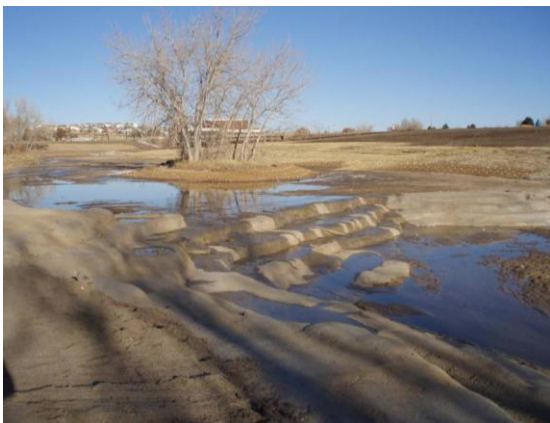
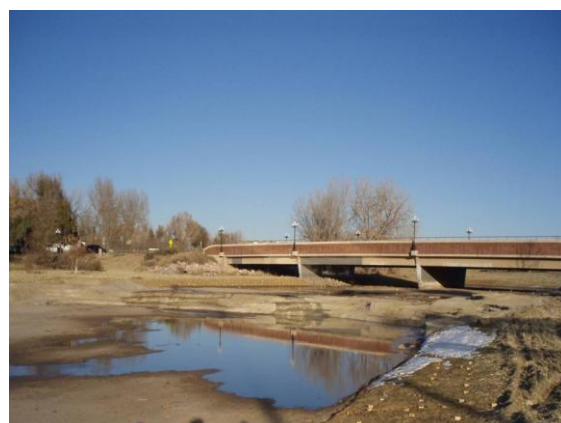
Two sculpted drop structures were also constructed

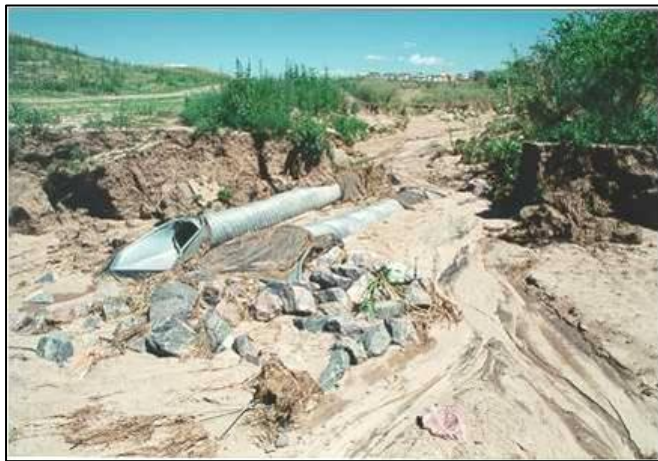
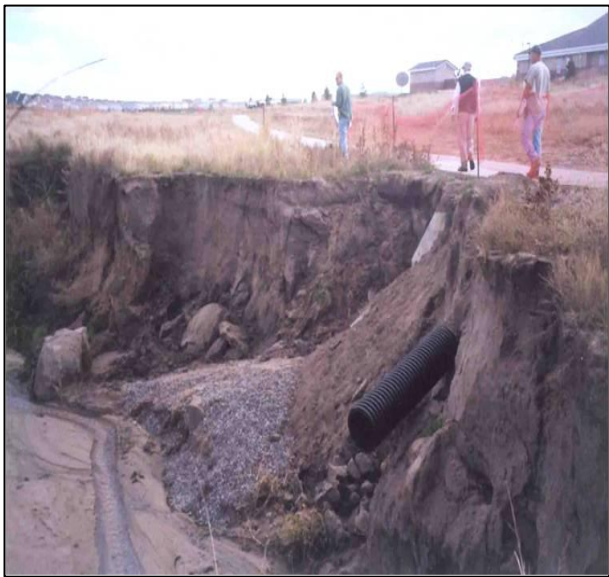
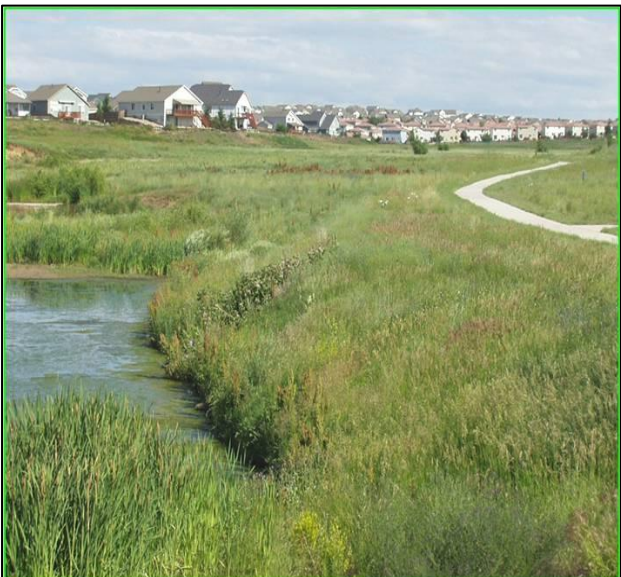
Phase 2 completed based on success of the soil cement drops and bank protection in the first phase. Total Phase 1 and 2 improvements constructed in upstream reaches: 18 soil cement drops constructed along with 400 ft of soil cement bank protection, 3000 ft of bioengineering bank protection and 6 trail crossings. Utilizing soil cement drops saved project approximately 15% of standard method costs.

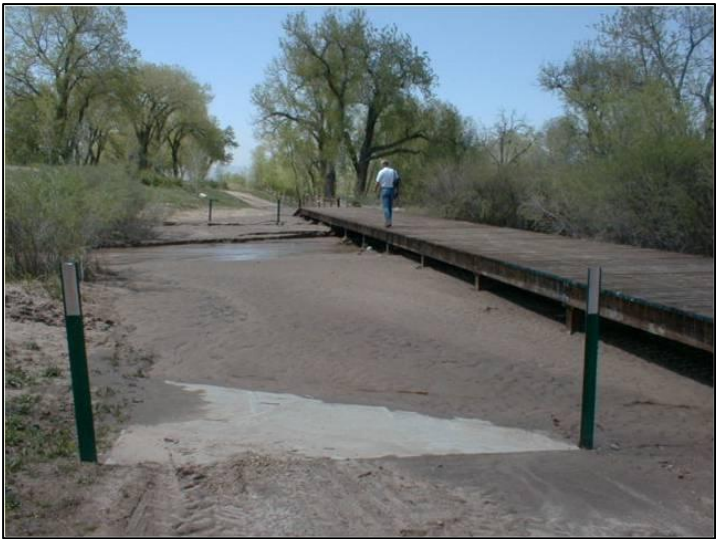
Downstream reaches (Highlands Ranch Golf Club) experiencing heavy aggradation due to upstream channel instability.

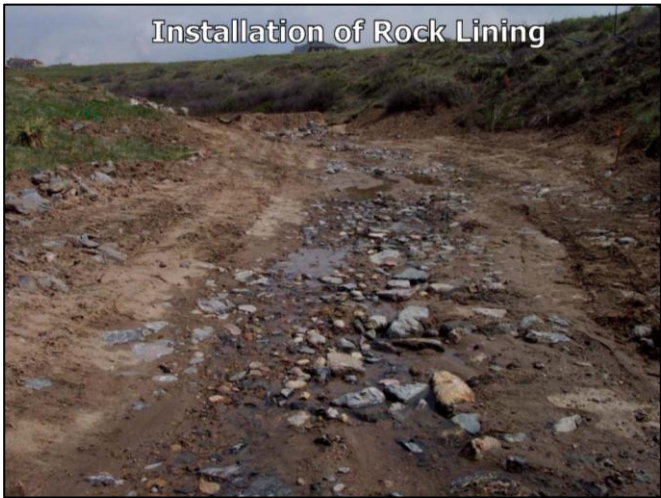
Installation of Rock Lining

New approach tried in a very steep reach towards upstream end of watershed. Instead of traditional drop structures with a flat slope in between, a low flow void-filled riprap channel lining at a steeper slope was used to minimize disturbance and number of drops. Results were a cost effective solution that introduced the District to a new material that provided structural protection with a good growing medium.

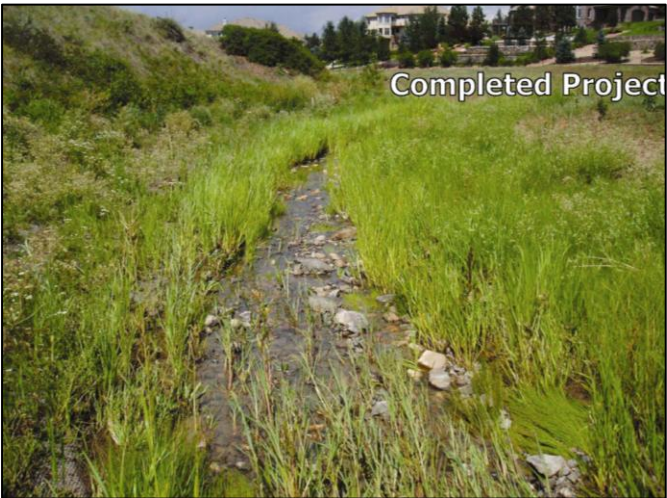
Completed Project

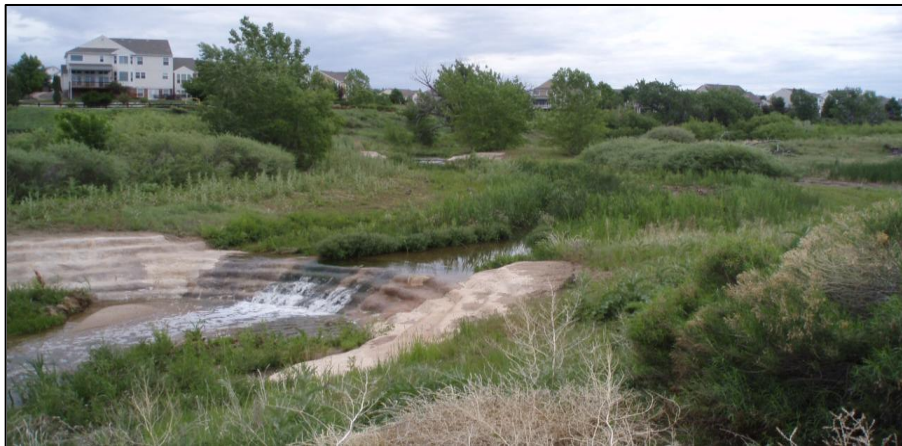
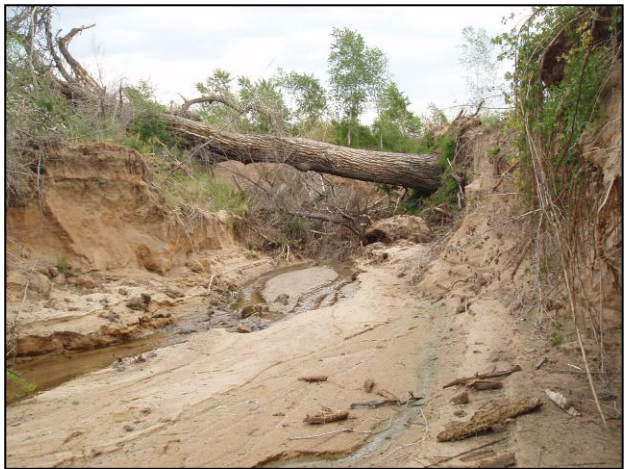
Project completed in reach upstream of Town Center Drive to stabilize the active channel using a combination of smaller sculpted concrete drops and low flow void-filled riprap lining, thus letting larger flows go outside of the banks and spread across the riparian corridor.

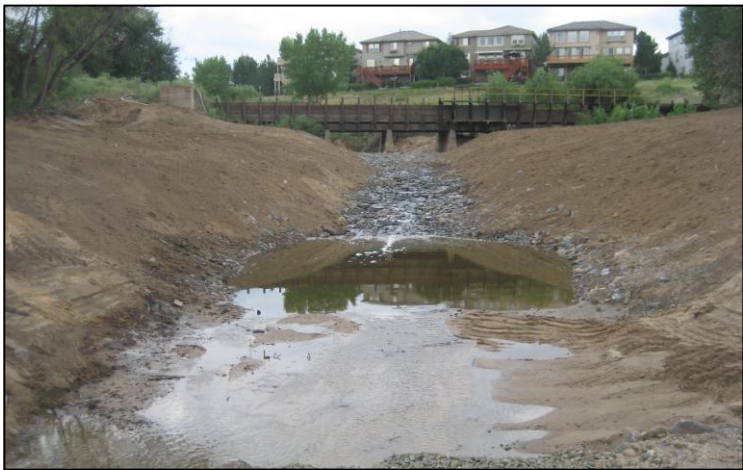
Emergency repair (void-filled riprap rundown) to temporarily stabilize head cut and protect Highline Canal, installed within 1 month of failure. Offered 10-yr protection and material was reused in final design.

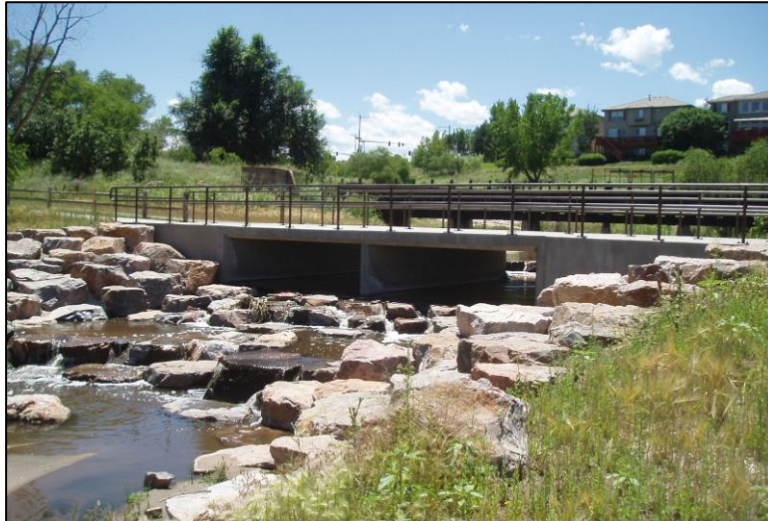
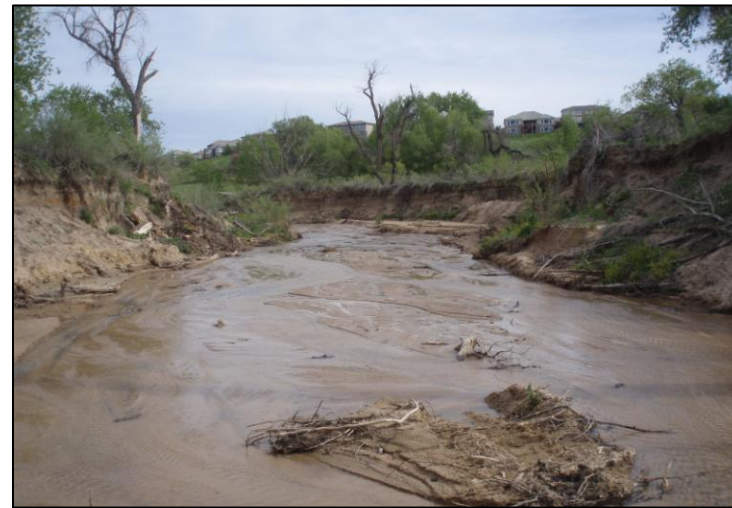
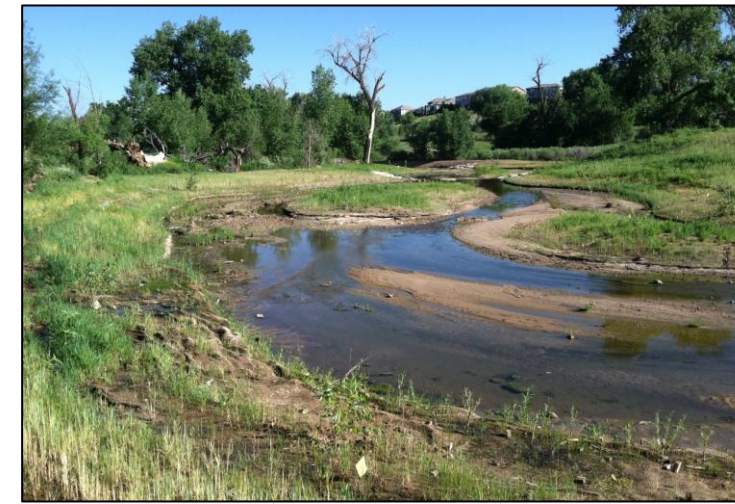
New dual cart and trail crossing constructed at Highlands Ranch Golf Club

Within the golf course reach, final design through construction was done in a total of 10 months. This was accomplished by bidding 90% design drawings among District drainageway contractors and breaking project into two phases. Design included improvements along 3,000 lf of channel, raising invert back up to predevelopment elevations (about 7-8 feet in upper reach and 4-5 feet in middle reach), building a total of 45 vertical feet of drop structures, and placing 36,000 cy of fill.

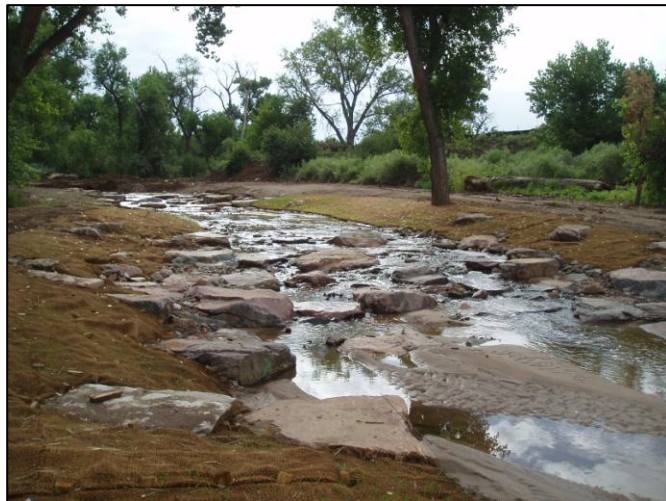
In middle reach of golf course, a new type of drop structure used: cascading loose boulder drop. Tested during high flow shortly after construction and performed as designed.

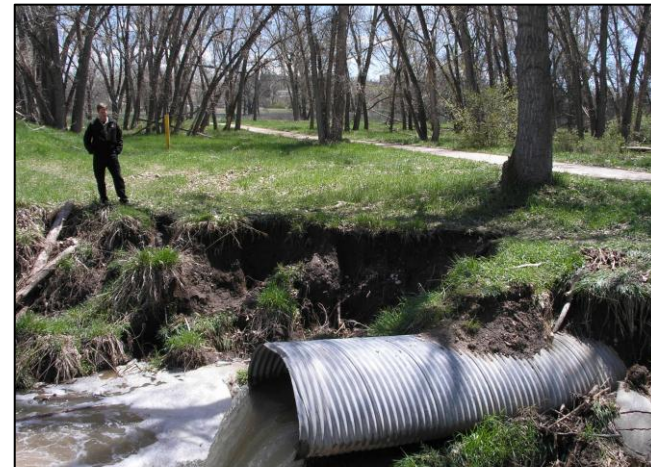
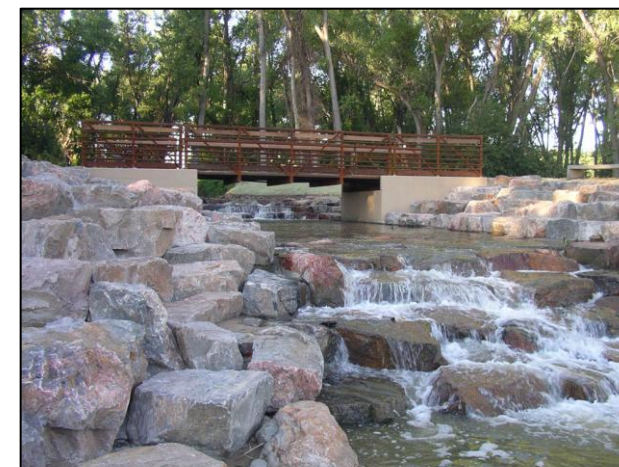
More severe damage also occurred near the confluence with the South Platte River. The regional trail crossing over Marcy was about to be washed out. An unprecedented group of local sponsors each contributed to the cost of this repair: Centennial Water and Sanitation District, Highlands Ranch Metro District, Littleton, Colorado Water Conservation Board, South Suburban Park and Recreation District, Colorado State Parks, Southwest Metro Water and Sanitation District and Douglas County, with cooperation from Army Corp of Engineers. Thank you.
